**Flood Control Project Maintenance
Levee Inspections**

Maintenance Issue Types Only, Levee Inspection Report By Mile - Spring 2018

Sacramento Maintenance Yard Willow Slough Bypass

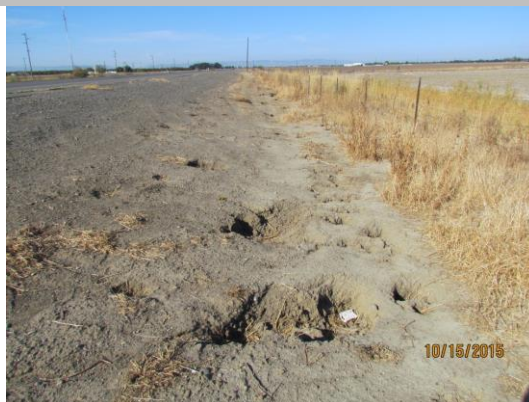
Photo 1 of 1 : SP_2018_ST0012_295_10_20180306_00003.jpg

LM Start	2.93	Rating **	M	Issue No.	10
LM End	3.00	Issue Type +	Ma	Location *	LS
Category	Earthen Levee			GPS Latitude/Longitude	
				Start	End
Item	Erosion / Bank Caving			38.590572 °	38.590653 °
				-121.719349 °	-121.720714 °
DWR ID	DWR_ST0012_01_s_2015_10				
Comment Code					
E1 : Note and monitor erosion site.					
Inspector Comment

View of the erosion on the landward side of the levee looking upstream.
Fall 2015.

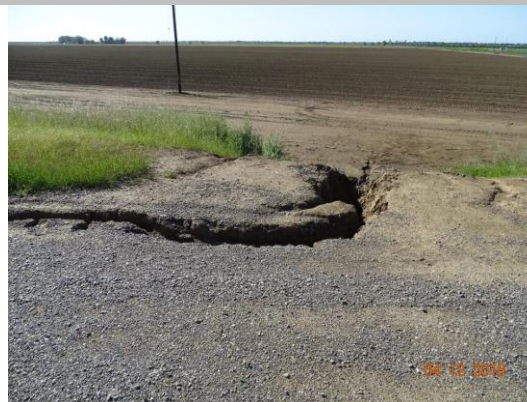
Photo 1 of 2 : SP_2018_ST0012_296_14_20180413_00035.jpg

LM Start	0.03	Rating **	A/W	Issue No.	14
LM End	0.03	Issue Type +	Ma	Location *	LS
Category	Earthen Levee			GPS Latitude/Longitude	
				Start	End
Item	Erosion / Bank Caving			38.598926 °	38.598926 °
				-121.753893 °	-121.753893 °
DWR ID	DWR_ST0012_02_f_2017_14				
Comment Code					
E2 : Schedule repair of erosion site prior to the next inspection.					
Inspector Comment					
Oversized section of levee with approximately 90' crown. Erosion on landside levee berm caused by runoff. Recommend monitoring

Updated view of erosion. Spring 2018.

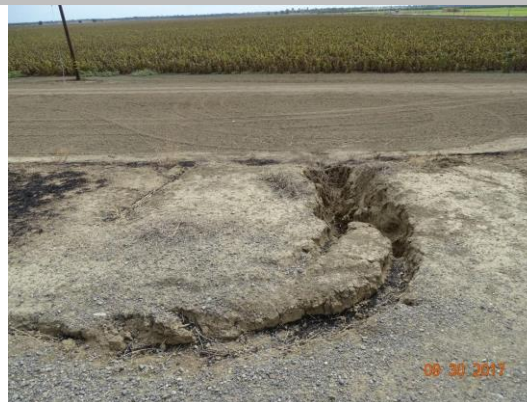
Photo 2 of 2 : SP_2018_ST0012_296_14_20180306_00018.jpg

View of erosion on landside slope. Fall 2017.

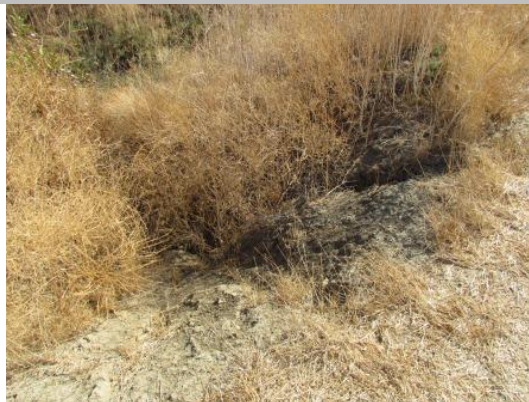
Photo 1 of 1 : SP_2018_ST0012_296_23_20180306_00027.jpg

LM Start	1.21	Rating **	A/W	Issue No.	23
LM End	1.21	Issue Type +	Ma	Location *	WS
Category	Earthen Levee			GPS Latitude/Longitude	
				Start	End
Item	Erosion / Bank Caving			38.593368 °	38.593368 °
				-121.735605 °	-121.735605 °
DWR ID	DWR_ST0012_02_f_2016_23				
Comment Code					
E1 : Note and monitor erosion site.					
Inspector Comment					
Erosion on waterward side at utility crossing. Doesn't appear to be within prism, but should be monitored.

View of an erosion site around UCIP pipe FSID 13725 on waterward side of the levee. Fall 2016.

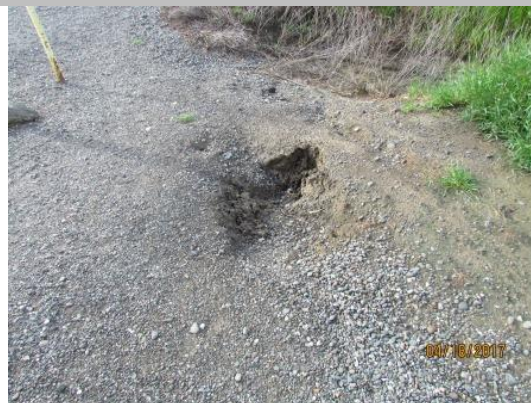
Photo 1 of 1 : SP_2018_ST0012_296_29_20180306_00028.jpg

LM Start	1.57	Rating **	M	Issue No.	29
LM End	1.57	Issue Type +	Ma	Location *	LS
Category	Earthen Levee			GPS Latitude/Longitude	
				Start	End
Item	Slope Stability			38.590064 °	38.590064 °
				-121.730723 °	-121.730723 °
DWR ID	DWR_ST0012_02_s_2017_29				
Comment Code					
S3 : Repair the levee slope damaged by vehicle traffic and prevent access where possible.					
Inspector Comment					
Tire damage on landside levee slope.

View of tire damage on landside levee slope. Spring 2017.

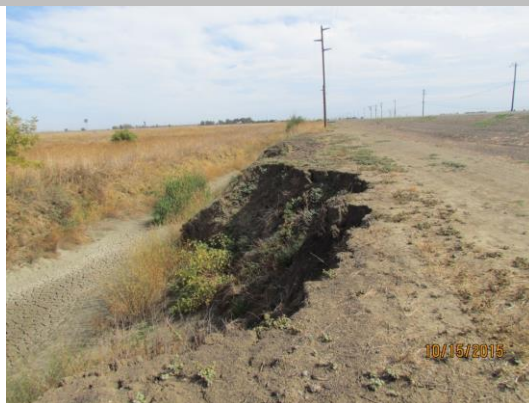
Photo 1 of 1 : SP_2018_ST0012_296_8_20180306_00008.jpg

LM Start	1.77	Rating **	M	Issue No.	8
LM End	1.77	Issue Type +	Ma	Location *	WS
Category	Earthen Levee			GPS Latitude/Longitude	
				Start	End
Item	Erosion / Bank Caving			38.589966 °	38.589966 °
				-121.727072 °	-121.727072 °
DWR ID	DWR_ST0012_02_s _ 2012_8				
Comment Code					
E1 : Note and monitor erosion site.					
Inspector Comment					
Erosion on waterside stability berm, at the edge of the road. Recommend monitoring.

View of the erosion on the edge of the channel looking downstream. Fall 2015.

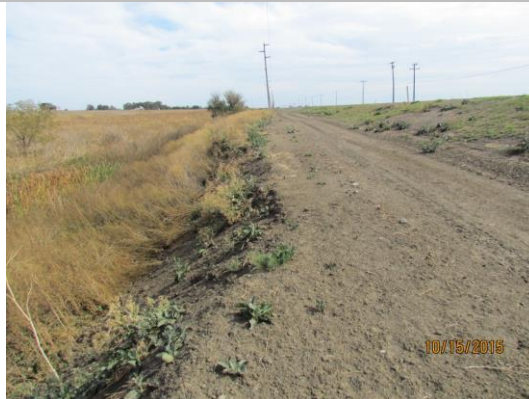
Photo 1 of 2 : SP_2018_ST0012_296_5_20180306_00003.jpg

LM Start	2.04	Rating **	A/W	Issue No.	5
LM End	2.04	Issue Type +	Ma	Location *	WS
Category	Earthen Levee			GPS Latitude/Longitude	
				Start	End
Item	Erosion / Bank Caving			38.589906 °	38.589906 °
				-121.722218 °	-121.722218 °
DWR ID	DWR_ST0012_02_s_2012_5				
Comment Code					
E1 : Note and monitor erosion site.					
Inspector Comment

View of the erosion on the edge of the channel on the waterward side of the levee looking downstream. Fall 2015.

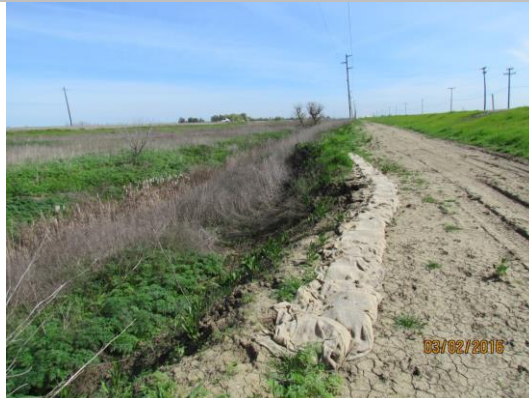
Photo 2 of 2 : SP_2018_ST0012_296_5_20180306_00004.jpg

View of the erosion on the edge of the channel on the waterward side of the levee looking downstream. Spring 2016.

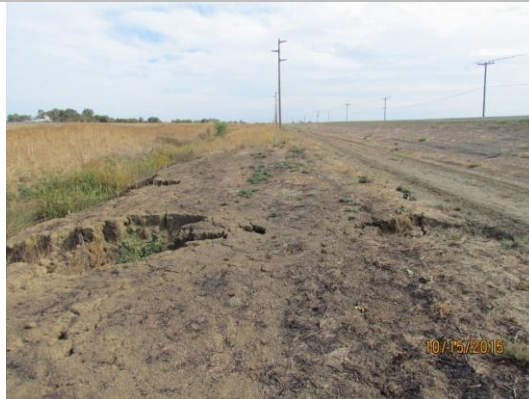
Photo 1 of 2 : SP_2018_ST0012_296_19_20180306_00024.jpg

LM Start	2.25	Rating **	A/W	Issue No.	19
LM End	2.25	Issue Type +	Ma	Location *	WS
Category	Earthen Levee			GPS Latitude/Longitude	
				Start	End
Item	Erosion / Bank Caving			38.589845 °	38.589845 °
				-121.718292 °	-121.718292 °
DWR ID	DWR_ST0012_02_f_2015_19				
Comment Code					
E1 : Note and monitor erosion site.					
Inspector Comment					
Erosion creeping onto toe road.

View of the erosion at the edge of the channel on the waterward side of the levee looking downstream. Fall 2015.

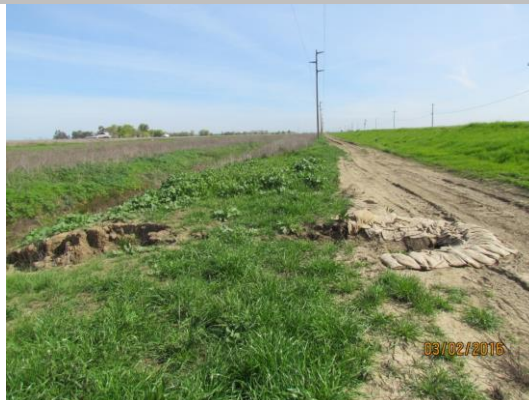
Photo 2 of 2 : SP_2018_ST0012_296_19_20180306_00025.jpg

View of the erosion at the edge of the channel on the waterward side of the levee looking downstream. Spring 2016.

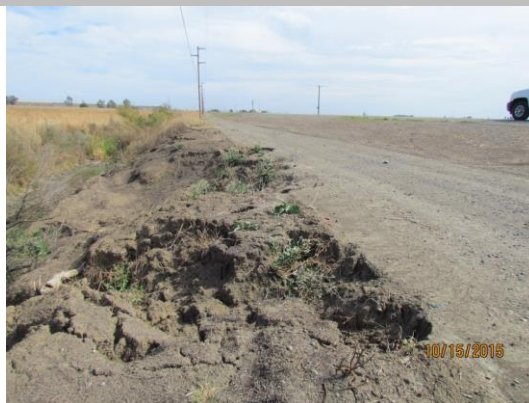
Photo 1 of 1 : SP_2018_ST0012_296_20_20180306_00026.jpg

LM Start	2.73	Rating **	A/W	Issue No.	20
LM End	2.73	Issue Type +	Ma	Location *	WS
Category	Earthen Levee			GPS Latitude/Longitude	
				Start	End
Item	Erosion / Bank Caving			38.589707 °	38.589707 °
				-121.709429 °	-121.709429 °
DWR ID	DWR_ST0012_02_f_2015_20				
Comment Code					
E1 : Note and monitor erosion site.					
Inspector Comment					
Erosion starting to creep onto the toe road.

View of the erosion at the edge of the channel looking downstream. Fall 2015.

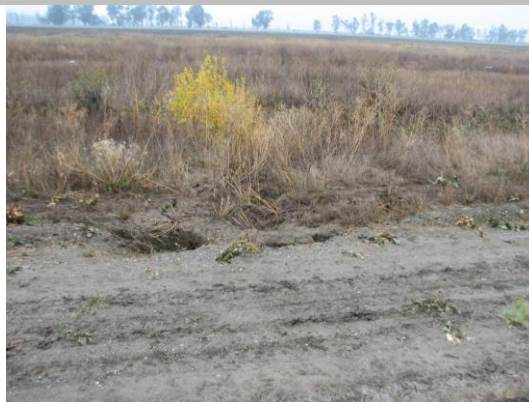
Photo 1 of 2 : SP_2018_ST0012_296_10_20180306_00012.jpg

LM Start	2.82	Rating **	A/W	Issue No.	10
LM End	2.82	Issue Type +	Ma	Location *	WS
Category	Earthen Levee			GPS Latitude/Longitude	
				Start	End
Item	Erosion / Bank Caving			38.589691 °	38.589691 °
				-121.707740 °	-121.707740 °
DWR ID	DWR_ST0012_02_f_2014_10				
Comment Code					
E1 : Note and monitor erosion site.					
Inspector Comment

Erosion on toe road. Fall 2014.

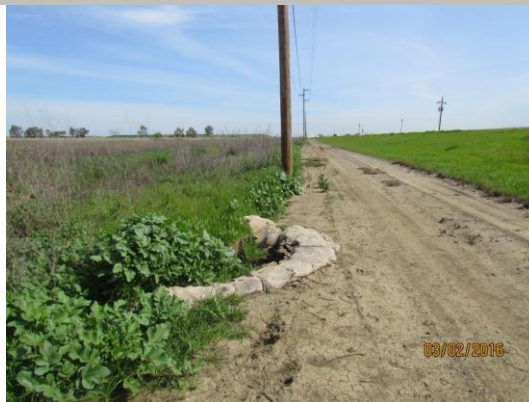
Photo 2 of 2 : SP_2018_ST0012_296_10_20180306_00013.jpg

View of the erosion on the toe road looking downstream. Spring 2016.

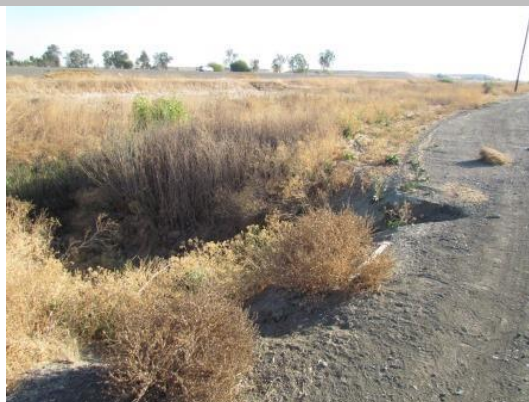
Photo 1 of 3 : SP_2018_ST0012_296_9_20180306_00009.jpg

LM Start	2.97	Rating **	A/W	Issue No.	9
LM End	2.97	Issue Type +	Ma	Location *	WS
Category	Earthen Levee			GPS Latitude/Longitude	
				Start	End
Item	Erosion / Bank Caving			38.589686 °	38.589686 °
				-121.705041 °	-121.705041 °
DWR ID	DWR_ST0012_02_f_2014_9				
Comment Code					
E1 : Note and monitor erosion site.					
Inspector Comment

An updated view of erosion site on waterward side. Fall 2016.

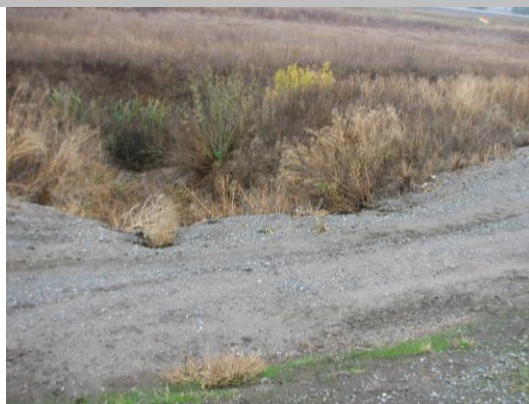
Photo 2 of 3 : SP_2018_ST0012_296_9_20180306_00010.jpg

Erosion on toe road. Fall 2014.

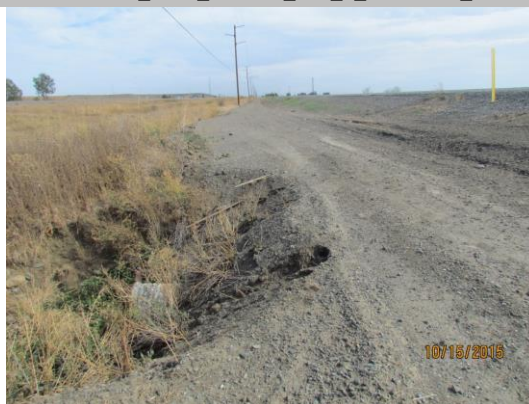
Photo 3 of 3 : SP_2018_ST0012_296_9_20180306_00011.jpg

View of the erosion on the waterward side of the levee looking downstream. Fall 2015.

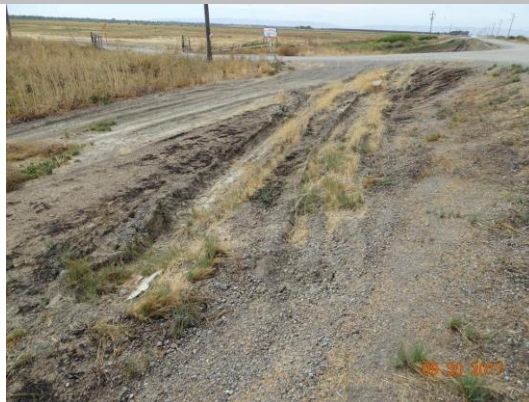
Photo 1 of 1 : SP_2018_ST0012_296_12_20180306_00017.jpg

LM Start	2.98	Rating **	M	Issue No.	12
LM End	2.98	Issue Type +	Ma	Location *	LS
Category	Earthen Levee			GPS Latitude/Longitude	
				Start	End
Item	Slope Stability			38.589673 °	38.589673 °
				-121.704690 °	-121.704690 °
DWR ID	DWR_ST0012_02_f_2017_12				
Comment Code					
S3 : Repair the levee slope damaged by vehicle traffic and prevent access where possible.					
Inspector Comment					
Tire ruts on landside slope.

View of tire ruts on landside slope. Fall 2017.

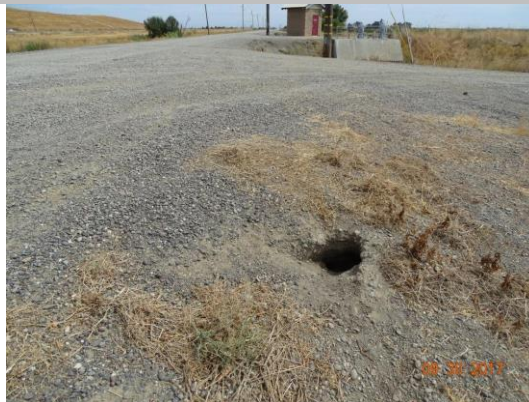
Photo 1 of 1 : SP_2018_ST0012_296_6_20180306_00005.jpg

LM Start	3.60	Rating **	M	Issue No.	6
LM End	3.60	Issue Type +	Ma	Location *	LS
Category	Earthen Levee			GPS Latitude/Longitude	
				Start	End
Item	Animal Control			38.589552 °	38.589552 °
				-121.693408 °	-121.693408 °
DWR ID	DWR_ST0012_02_f_2017_6				
Comment Code					
A3 : No rodents visible, but rodent burrows visible; need to backfill and compact or grout burrows.					
Inspector Comment					
Burrow hole on landside slope near access ramp.

View of burrow hole near access ramp on landside. Fall 2017.

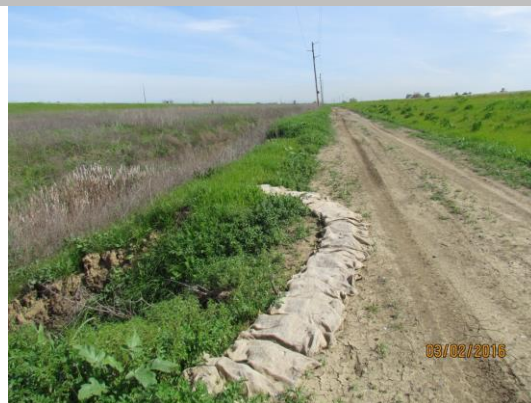
Photo 1 of 1 : SP_2018_ST0012_296_18_20180306_00023.jpg

LM Start	3.95	Rating **	A/W	Issue No.	18
LM End	3.95	Issue Type +	Ma	Location *	WS
Category	Earthen Levee			GPS Latitude/Longitude	
				Start	End
Item	Erosion / Bank Caving			38.589508 °	38.589508 °
				-121.686850 °	-121.686850 °
DWR ID	DWR_ST0012_02_s_2016_18				
Comment Code					
E1 : Note and monitor erosion site.					
Inspector Comment

View of the erosion on the waterward side looking downstream. Spring 2016.

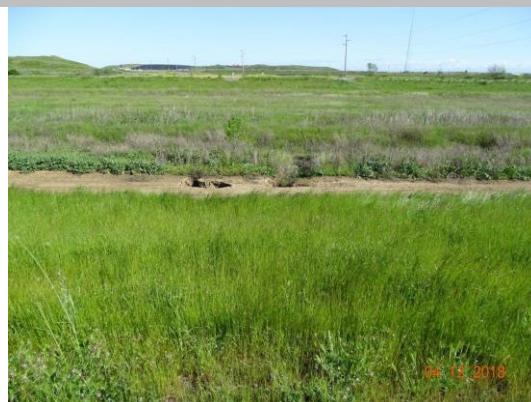
Photo 1 of 1 : SP_2018_ST0012_296_24_20180413_00036.jpg

LM Start	4.09	Rating **	A/W	Issue No.	24
LM End	4.09	Issue Type +	Ma	Location *	WS
Category	Earthen Levee			GPS Latitude/Longitude	
				Start	End
Item	Erosion / Bank Caving			38.589538 °	38.589538 °
				-121.684177 °	-121.684177 °
DWR ID	DWR_ST0012_02_s_2018_24				
Comment Code					
E1 : Note and monitor erosion site.					
Inspector Comment					
Runoff erosion on waterside toe road. Recommend monitoring.

View of erosion on the waterside toe road. Spring 2018.

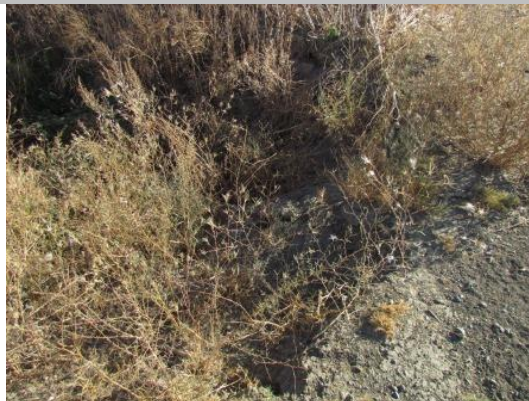
Photo 1 of 3 : SP_2018_ST0012_296_11_20180306_00014.jpg

LM Start	4.29	Rating **	A/W	Issue No.	11
LM End	4.29	Issue Type +	Ma	Location *	WS
Category	Earthen Levee			GPS Latitude/Longitude	
				Start	End
Item	Erosion / Bank Caving			38.589550 °	38.589550 °
				-121.680632 °	-121.680632 °
DWR ID	DWR_ST0012_02_f_2014_11				
Comment Code					
E1 : Note and monitor erosion site.					
Inspector Comment					
Erosion is near waterside toe on waterside berm at storm drain. Recommend monitoring.

An updated view of the erosion site near the WS levee slope. Fall 2016.

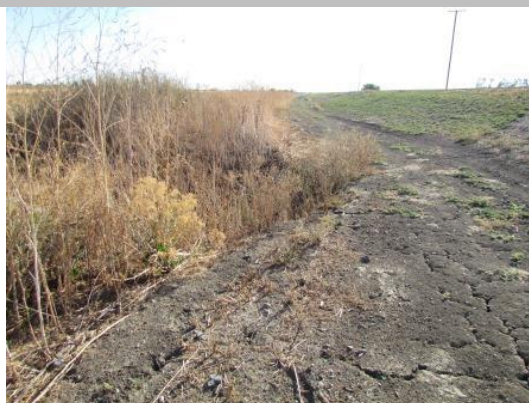
Photo 2 of 3 : SP_2018_ST0012_296_11_20180306_00015.jpg

Perspective view of the site. Fall 2016.

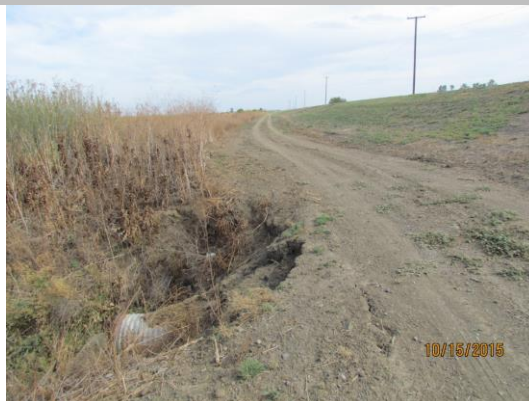
Photo 3 of 3 : SP_2018_ST0012_296_11_20180306_00016.jpg

View of the erosion at the edge of the channel on the waterward side of the levee looking downstream. Fall 2015.

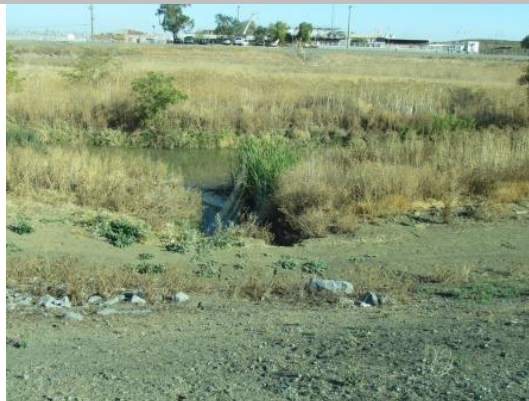
Photo 1 of 3 : SP_2018_ST0012_296_15_20180306_00019.jpg

LM Start	5.05	Rating **	A/W	Issue No.	15
LM End	5.05	Issue Type +	Ma	Location *	WS
Category	Earthen Levee			GPS Latitude/Longitude	
				Start	End
Item	Erosion / Bank Caving			38.589570 °	38.589570 °
				-121.666588 °	-121.666588 °
DWR ID	DWR_ST0012_02_s_2015_15				
Comment Code					
E1 : Note and monitor erosion site.					
Inspector Comment					
Erosion near levee toe on waterside berm at storm drain. Recommend monitoring.

An updated view of the erosion site near the levee slope. Fall 2016.

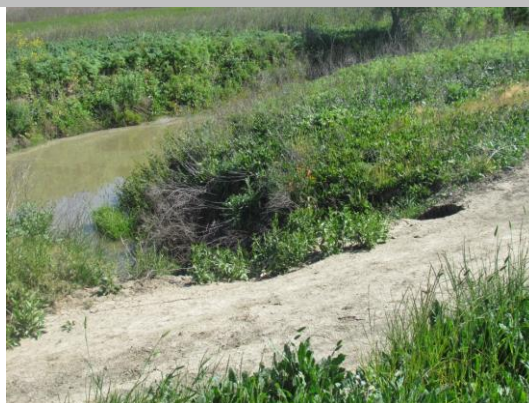
Photo 2 of 3 : SP_2018_ST0012_296_15_20180306_00020.jpg

View of the erosion on the edge of the channel on the waterward side of the levee. Spring 2015.

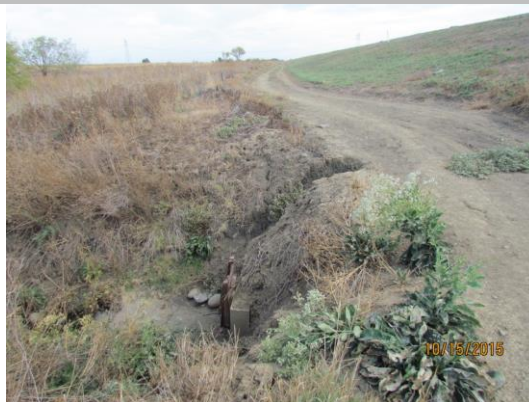
Photo 3 of 3 : SP_2018_ST0012_296_15_20180306_00021.jpg

View of the erosion at the edge of the channel on the waterward side of the levee looking downstream. Fall 2015.

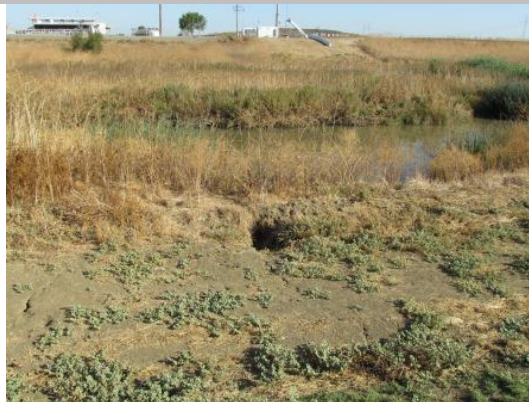
Photo 1 of 1 : SP_2018_ST0012_296_17_20180306_00022.jpg

LM Start	5.09	Rating **	A/W	Issue No.	17
LM End	5.09	Issue Type +	Ma	Location *	WS
Category	Earthen Levee			GPS Latitude/Longitude	
				Start	End
Item	Erosion / Bank Caving			38.589565 °	38.589565 °
				-121.665731 °	-121.665731 °
DWR ID	DWR_ST0012_02_f_2016_17				
Comment Code					
E1 : Note and monitor erosion site.					
Inspector Comment

View of a site that may become a larger erosion site in the future.
Waterward side of the levee looking downstream. Fall 2016.
